POSITIVE EFFECT OF HYALURONAN-IODINE COMPLEX IN EXTENSIVE WAR INJURY AFTER FAILURE OF VAC THERAPY - CASE REPORT

Martin Oberreiter¹, Ivo Zvak²,
³Jan Österreicher
¹6th Field Hospital Hradec Kralove, University Hospital Hradec Kralove, Czech Republic
²7th Field Hospital Hradec Kralove, University Hospital Hradec Kralove, Czech Republic
³Hospital Base Hradec Kralove, Czech Republic

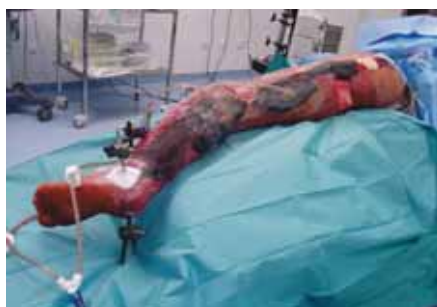
Vacuum assisted closure - standard treatment

18-year-old Afghan soldier, survivor of IED (Improvised Explosive Device) complex trauma of the left leg. After primary surgical treatment, negative pressure therapy was indicated. However, ten days after negative pressure was started, extensive bacterial colonization of the wound

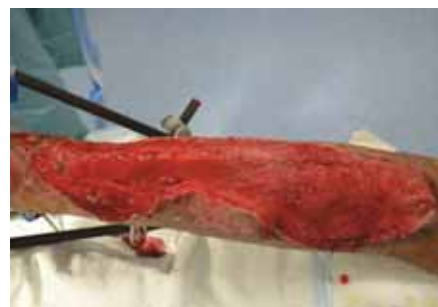
Wound with signs of infection

was apparent under the foam. Therefore, the treatment strategy was changed. The wound was dressed daily with HI-soaked gauze. After four days of this treatment, the wound was clean and granulated. Dermo-epidermal meshed skin grafts were applied and 95% was successfully healed in total. The patient's soft tissues healed completely and the patient was able to walk with crutches just 6 weeks after the initial injury.

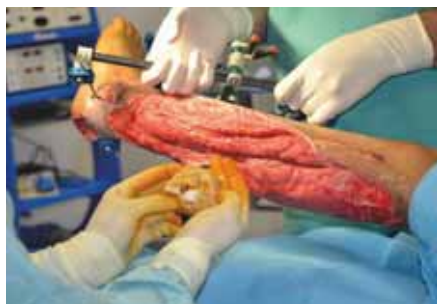
Application of hyaluronan iodine dressing

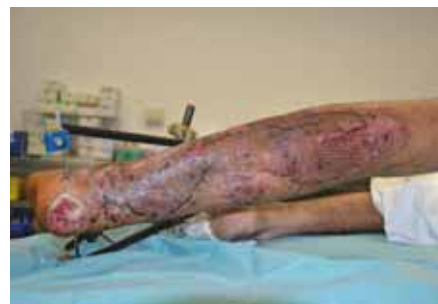
Wound after application of meshed grafts, close to complete healing
